UTAH COMMUNICATIONS AUTHORITY

UCA Chat - Radio Troubleshooting Tips 12-19-2024

Radio Troubleshooting Tips

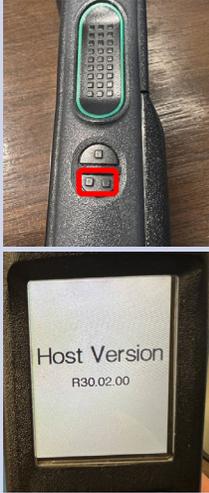
Motorola Portable		L3H Portable	
<ol style="list-style-type: none"> 1. Power on radio 2. Within 3 seconds of powering the radio on, press the two dot button under the ptt button on the right side of the radio 5 times within the first 10 seconds of powering the radio on. 3. Record the "Host Version" number, this is the firmware version 4. Current version is 34.00, older versions have proven to have issues communicating with the p25 radio system

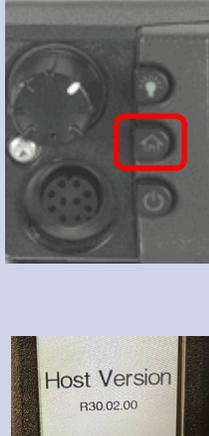
<ol style="list-style-type: none"> 1. Power on radio 2. Within 3 seconds of powering the radio on, press the home button on the radio 5 times within the first 10 seconds of powering the radio on. 3. Record the "Host Version" number, this is the firmware version 4. Current version is 34.00, older versions have proven to have issues communicating with the p25 radio system

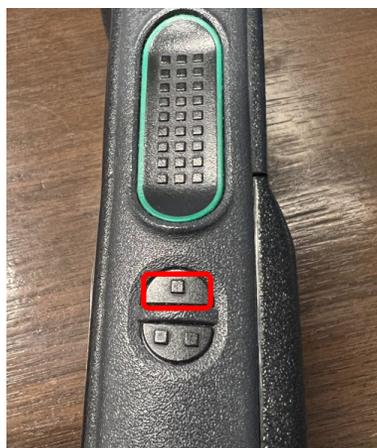
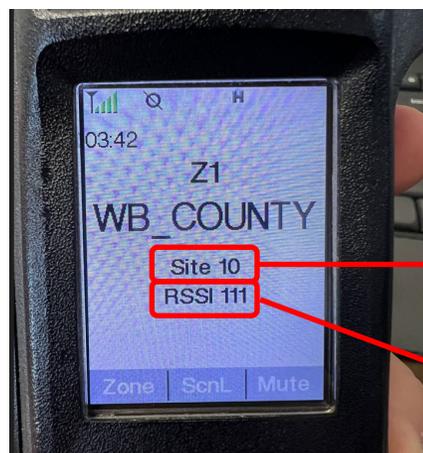
Motorola Portable

Press up Button Site Number and Signal Strength (RSSI) will appear temporarily

Site

Signal

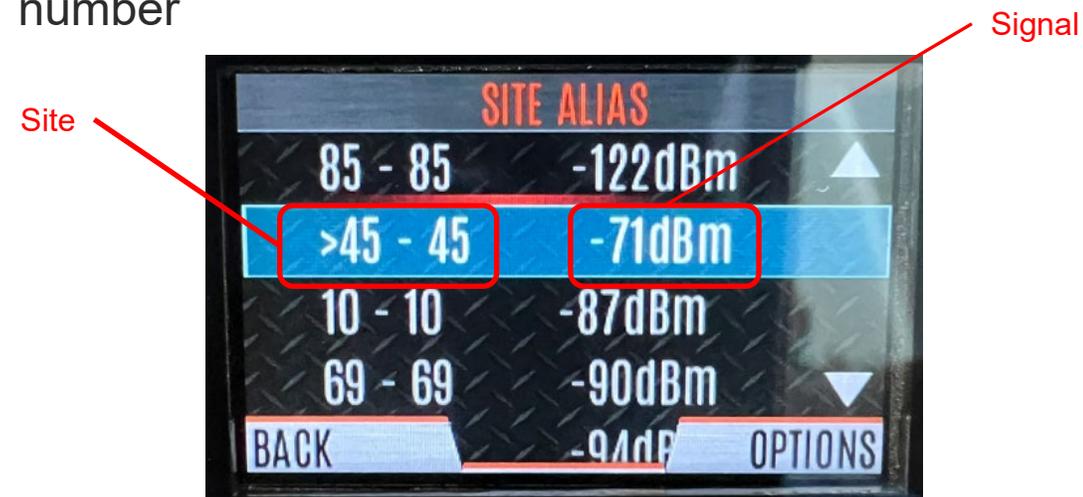
L3H Portable

1. Press the center menu button
2. Arrow Right to once to "S" Icon
3. Arrow down to "site alias", press center button
4. The site shown with the > symbol is the site your radio is attached to. The site number is formatted XX-XX
5. The signal level will be to the right of the site number
